**2008 Operations,  
Maintenance and Monitoring  
Report**

**North Lake Mechant Landbridge  
Restoration – Construction Unit 1**

State Project Number TE-44  
Priority Project List 9

August 2008  
Terrebonne Parish

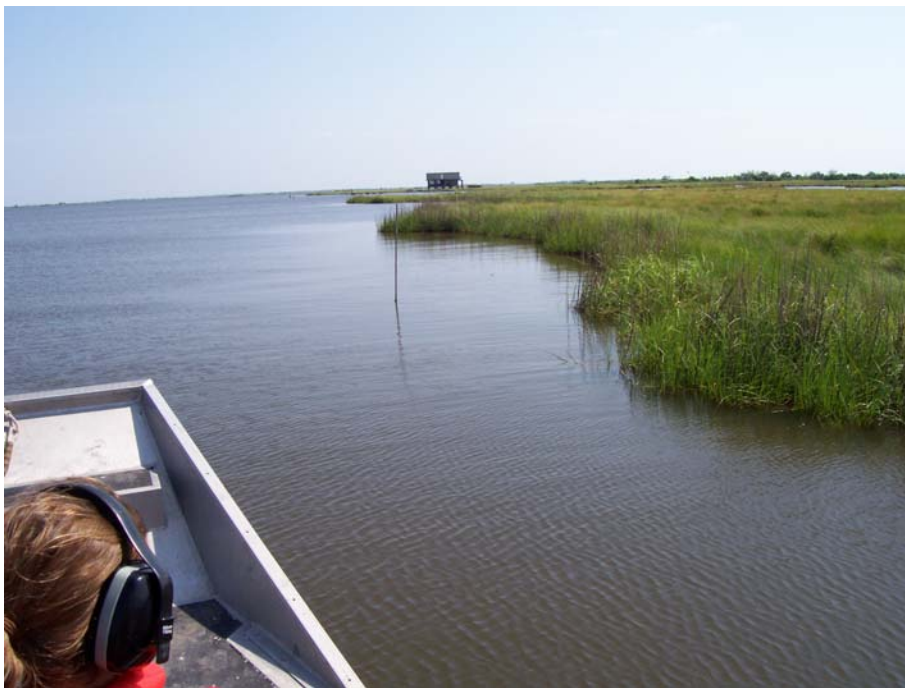
Photo 4. Lake Paige, Section B shoreline looking northward, existing vegetation plot in water.

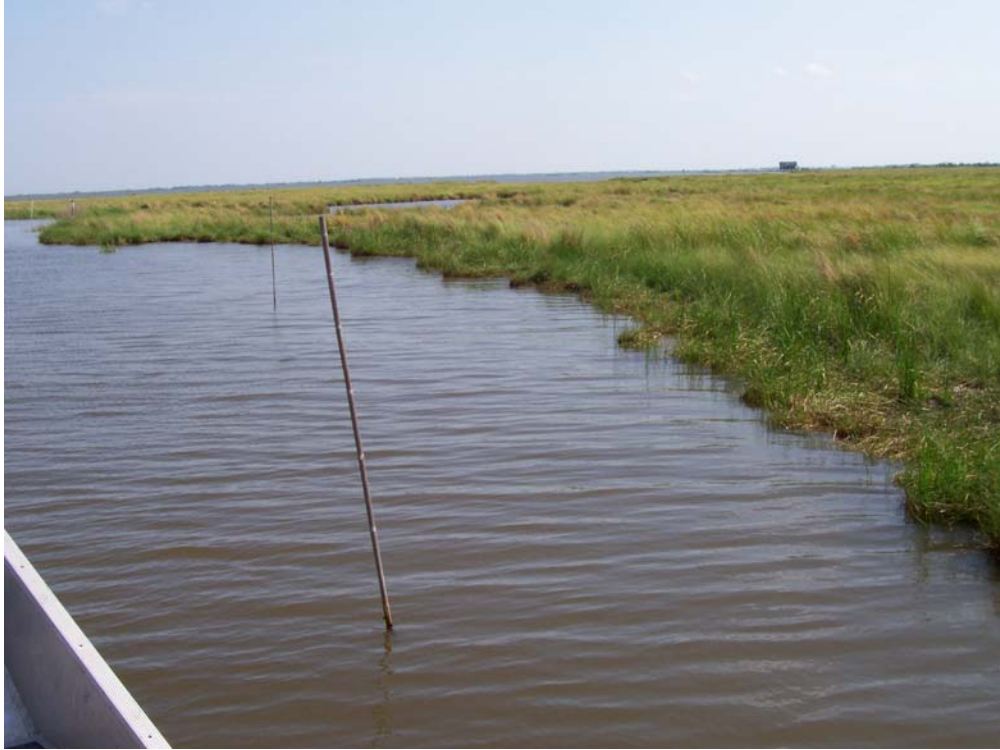
Photo 5. Lake Paige, Section C shoreline looking north, existing vegetation plots in water.

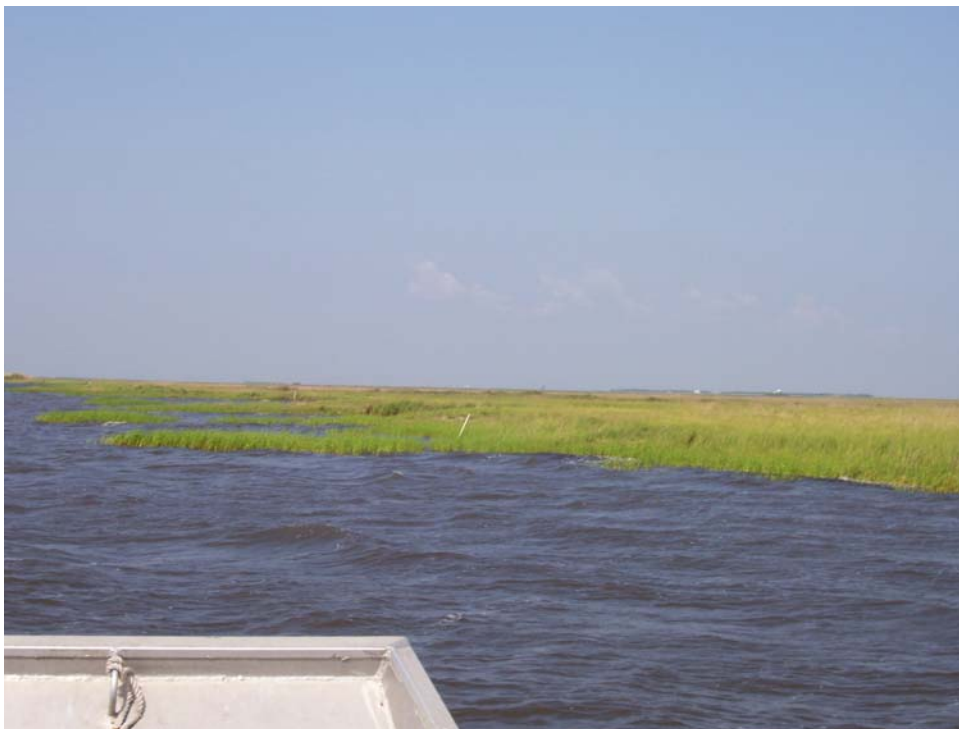
Photo 8. Lake Mechant, Section F eastern portion of section looking toward section F. Finger of marsh extending from bank line.

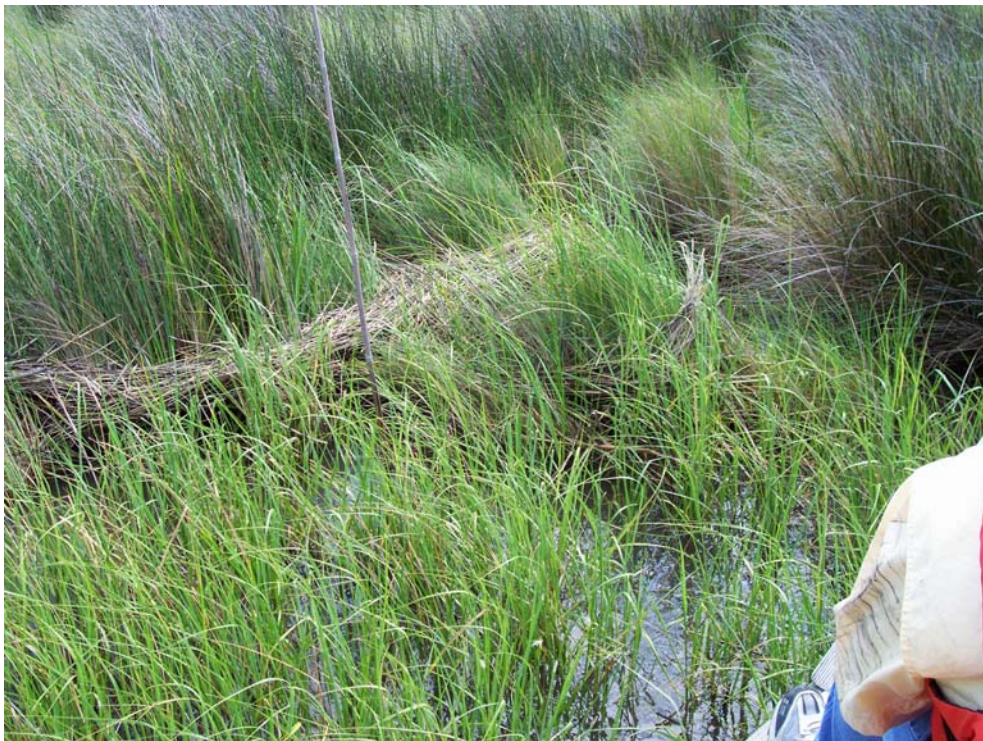
Photo 12. Lake Mechant, Section J, vegetation plot showing vegetation distribution along shoreline.
